PROPERTY REPORT AND NEGOTIATION DOCUMENT

XXXX
Margate,
Kent.
CT9 XXX

INTRODUCTION

We have been instructed to inspect and prepare a Property Report and Schedule of Condition for:

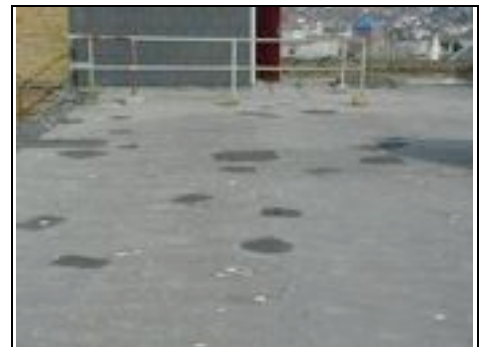
The main roof consists of asphalt finish to the flat areas and slate sides. Asphalt is generally considered to be one of the best flat roofing materials; unfortunately this asphalt is coming to the end of its useful life and needs major repair.

Patch repairs looking towards the rear of the property

ACTION REQUIRED: We recommend the asphalt is repaired. In some areas this may involve re-asphalting.

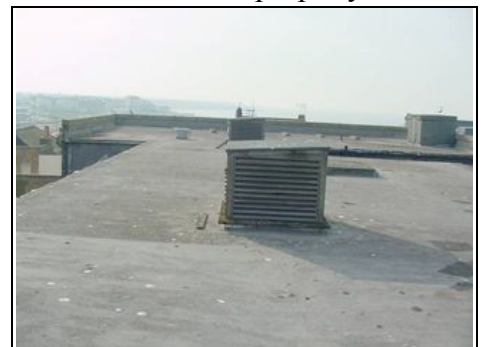
Looking towards the front of the property

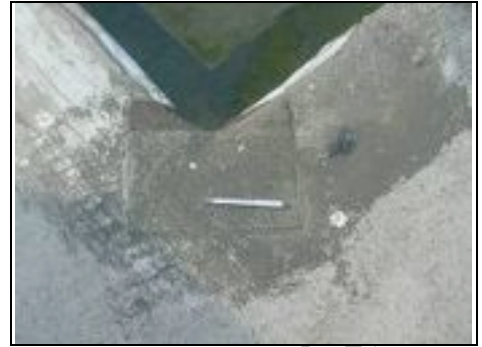
It has been patch repaired poorly in the past and needs to be properly repaired with asphalt detailing, particularly around the parapet walls and around the upstands, such as the roof windows and the vent.

Example of patch repair

ANTICIPATED COST: This should be at the landlord's expense or alternatively exclude the main roof from the lease; please obtain quotations.

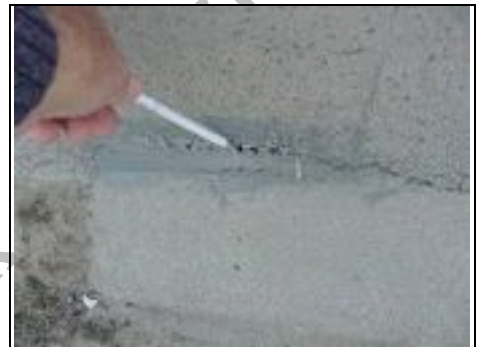
Cracking to asphalt

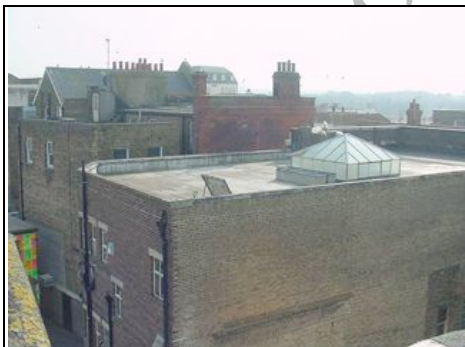
There is a parapet wall at the front and the rear of the property, which we believe are allowing dampness into the property. The cracking and the weathered joints indicate that water is getting in.

Front and side parapet walls

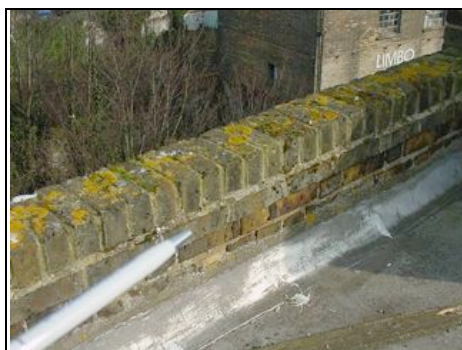
Moss on rear parapet wall indicating that dampness is getting in

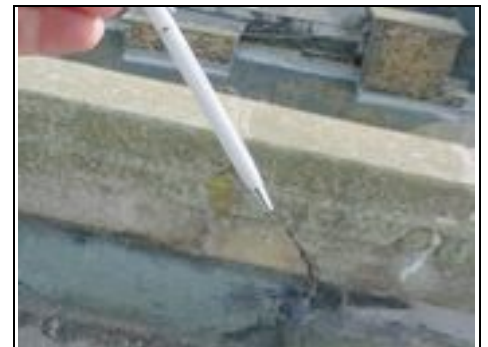
Cracking to parapet

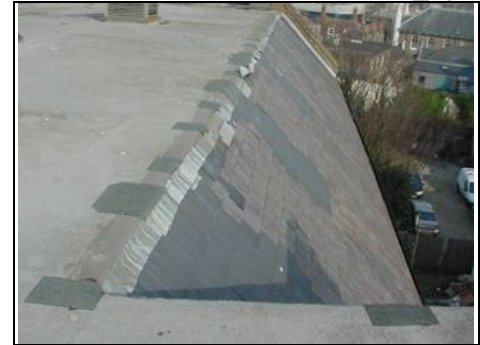
Slate roof

The slate roof has had major repairs over the years but we can still see problems relating to the slate roof.

ACTION REQUIRED: Exclude the slate roof from the terms of the lease and ensure/insist upon the landlord repairing the roofs that may cause danger to the public below.

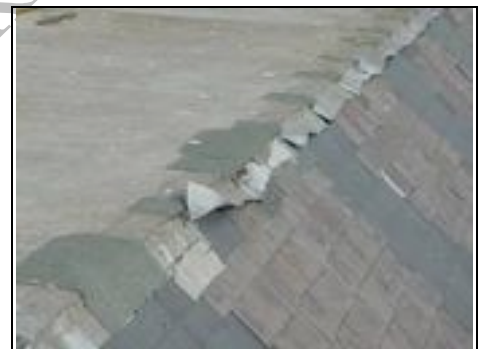
- 1) The fixing of nails have rusted.
- 2) Accelerated wind pressure between the surrounding buildings.
- 3) Unfortunately repaired roofs, such as this, where the repairs are fairly major never sit as level and true as an unrepaired slate roof.
- 4) Inherent defects. The detailing where the pitched roof meets the flat roof is not ideal and we can see areas, which have been lifted by the wind.

Old repairs lifting

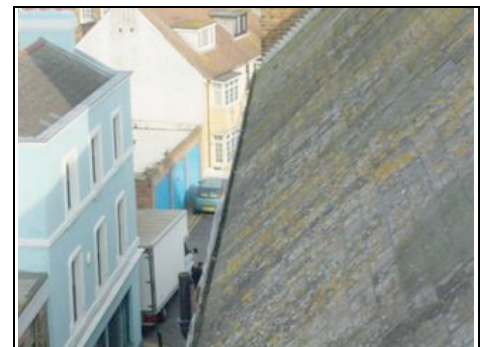
Slate guard

Be warned that the roof is in such a poor state that on the left hand side with the footpath and road beneath a slate guard has been put in place and you will of course have a liability if there are any accidents.

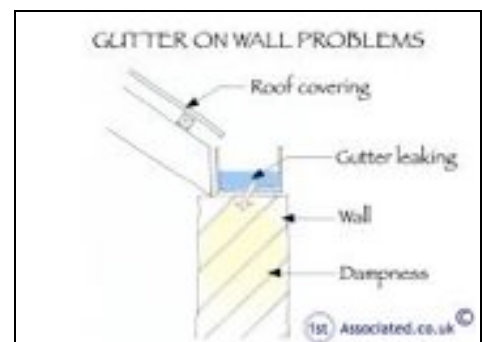
The property has sit on gutters. These are at the bottom of the slate roof and are full of vegetation and generally blocked. Unfortunately as they are sit on gutters this then means the water goes into the structure.

Sit on gutters

ACTION REQUIRED: Clear the sit on gutters and make them watertight. We believe they are allowing water to leak into the structure. Adding roof windows may be a way forward on this but further investigation is required.

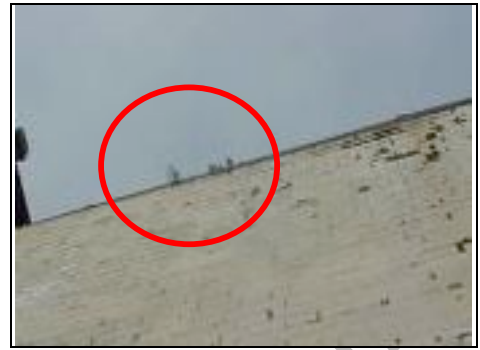
Sit on gutter full of vegetation

ANTICIPATED COST: In the region of £250 to £500 per roof window; a total cost in the region of £5,000 plus scaffolding if the work cannot be carried out from within the property. The work itself will cost £1,000 - £3,000. Please obtain quotations. You will of course need to cordon off the area below.

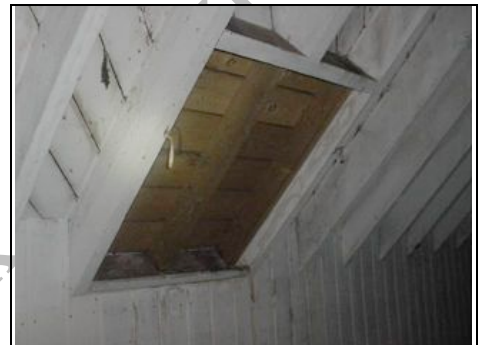
Blocked up roof window

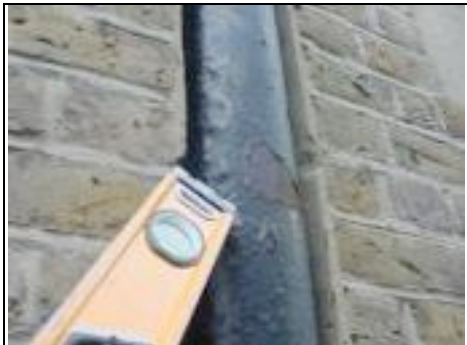
There are problems with the sit on gutters overflowing and associated dampness together with general leaking of soil and vent pipes and downpipes (although it does look like some of these have been repaired fairly recently).

Rusting to gutters

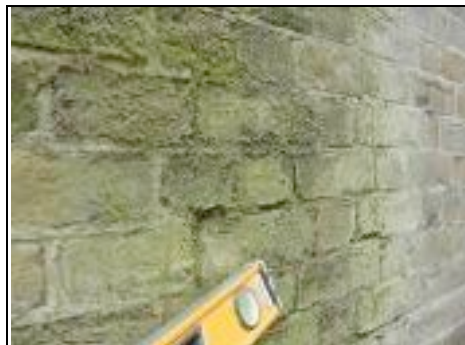
The brickwork that remains is weathered with moss and efflorescence visible as well as graffiti.

Weathering to brickwork

ACTION REQUIRED: Once the previously mentioned problems have been resolved ad hoc repointing is needed together with general cleaning of the brickwork. In addition to this there are specific problems to the front elevation, please read on.

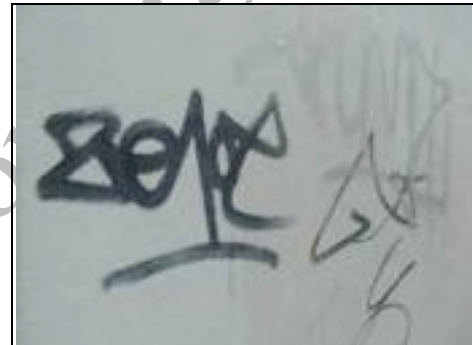
Graffiti

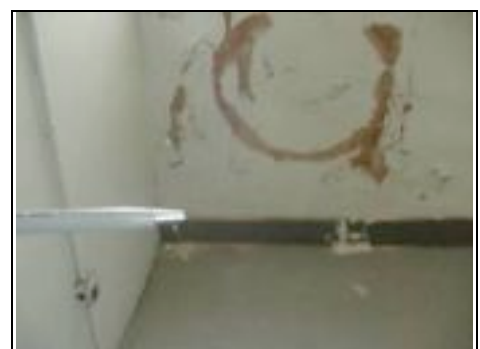
We can see lateral dampness to the property has occurred to the front elevation. This is visible within the kitchen and the office rooms to the front of the property and also within the right hand and rear staircases.

We feel to the front and left side of the property where lateral dampness was present is due to a combination of

Dampness in kitchen

- 1) The weathered pointing and the leaking gutters as previously mentioned
- 2) The stonework with ledges, although we were pleased to see there looked to be drainage points in the ledges but we do still feel it may be susceptible to dampness.

ACTION REQUIRED: You need to ensure that the ledges/cornices are draining properly and that the roof material, which looks to be an asphalt is watertight.

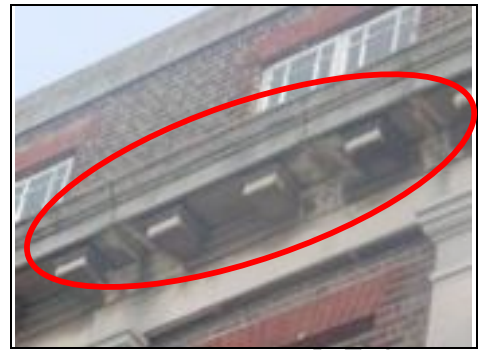
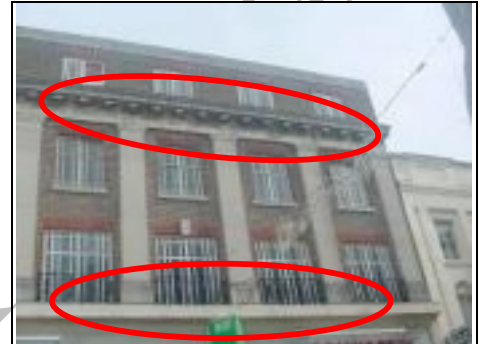
Ledges/cornices

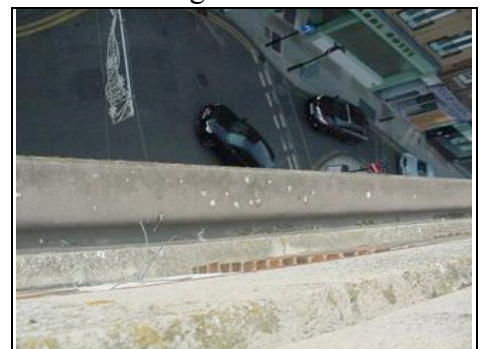
Top of ledge

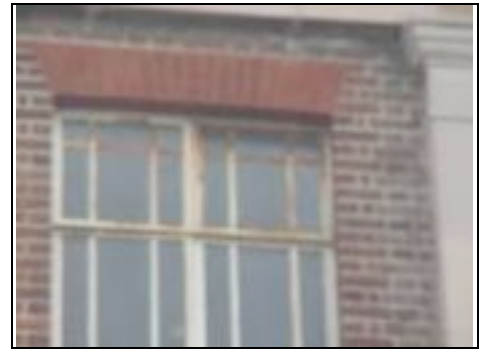
There is a mixture of the original old cast iron windows and replacement timber windows. All are in need of repair, preparation and redecoration.

Rusting

ACTION REQUIRED: Repair, prepare and redecorate.

ANTICIPATED COST: This is a major job. We would expect costs in the region of £25,000 - £50,000 to repair the windows together with associated scaffolding; please obtain quotations.

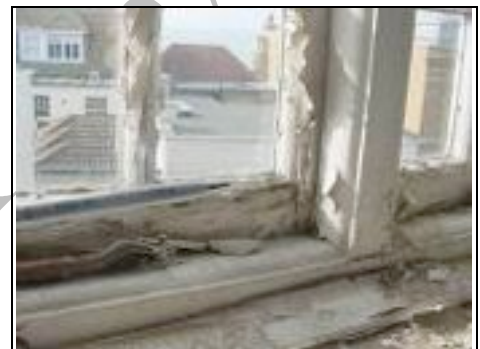
Flaking paint

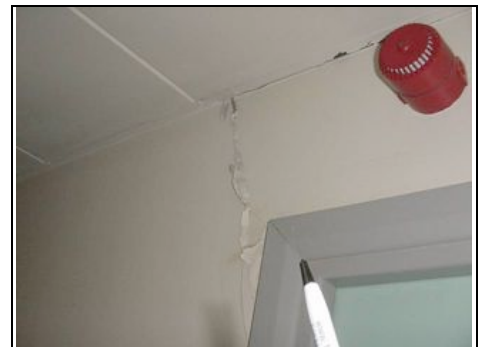
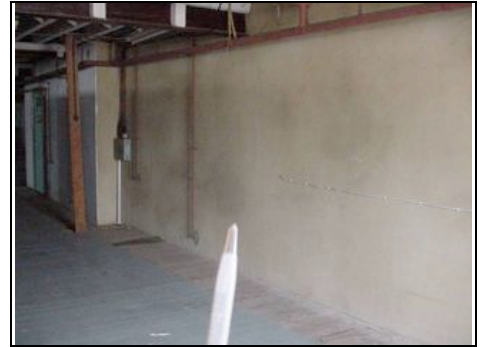
We can see movement to approximately the first third of the building. This runs through the building and is visible to a lesser or greater extent. There are a number of reasons for the problems:

Cracking to right side

- 1) There may be a difference in the construction techniques in this area.
- 2) There may be different foundations in this area.
- 3) There may be a weakness in the soil strata.
- 4) We believe that dampness into the structure is contributing to the movement.
- 5) There may be a fundamental weakness in the property construction.

ACTION REQUIRED: Ideally we would recommend the existing owners take out an insurance claim, advising that the cracking has been noted by a structural surveyor (this should cost them nothing other than time to write the letter). This usually means that the insurance company will carry out a monitoring exercise (the Building Research Establishment recommend monitoring any cracks for a minimum of one year) to establish if there is any progressive movement. The liability will be to the landlord. Alternatively exclude any cracking and movement from the lease.

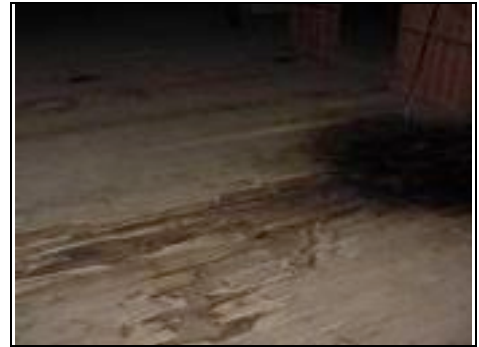
We noticed there was staining to many of the roof joists/timbers and indeed many of the floor timbers/joists. In some areas this is just staining, in other areas this has developed into wet rot and dry rot, for example:

Staining to floor

ACTION REQUIRED: We believe the only way forward with a Full Repairing lease is to exclude these areas from the lease in a Schedule of Condition. Even with a Schedule of Condition there is a risk of areas developing that are not seen at the time/not visible at the time of inspection.

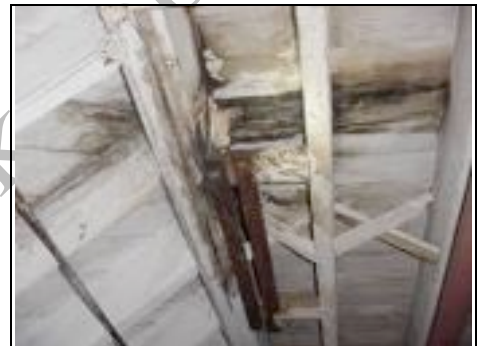
Leak

3.1) There are also half a dozen lesser areas which had severe dampness, and on a more general note light could physically be seen coming through the slate roof, which of course in turn will mean that rainwater will come through, not to mention wind driven rain. Therefore there is likely to be deterioration to the close boarding that is beneath the slates.

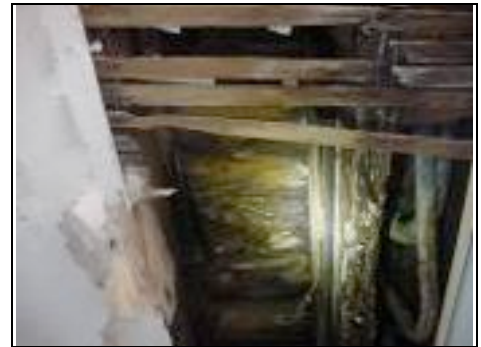
Ceiling down in left corner

Ideally we believe that the landlords should carry out full repair works to the main roofs to make the property watertight. This would then allow the property to be brought up to standard.

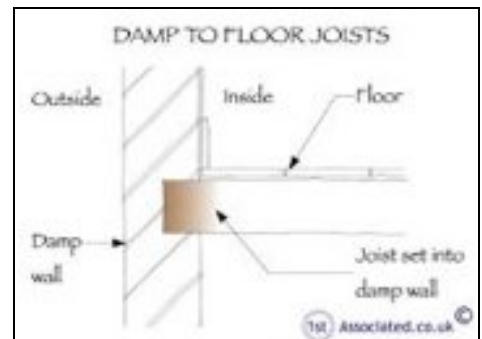
There looks to have been extensive dry rot to the basement particularly at the front on the left hand side, which is resulting in acro propping of the area. There may also have been problems with the embedded joists rotting. The problem is certainly known about as the acro props look relatively new (in this instance we mean in the last five years or so).

Rot to embedded timbers

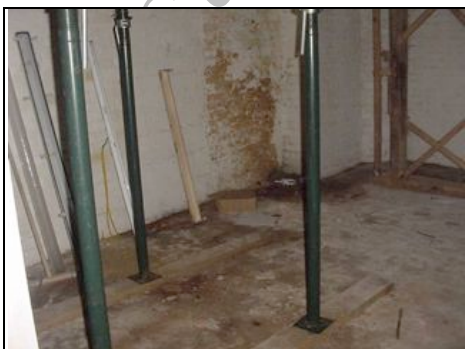
Acro props

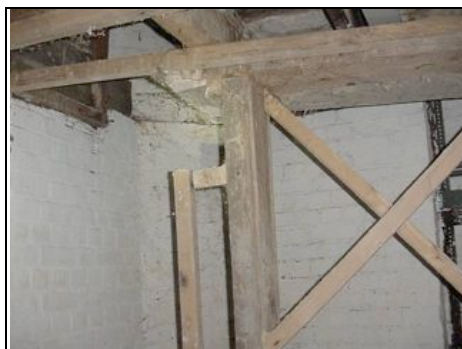
Timber support

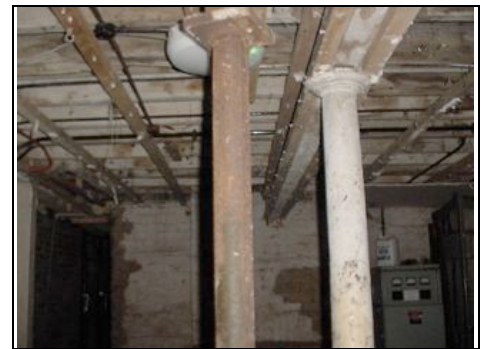
Cast iron support

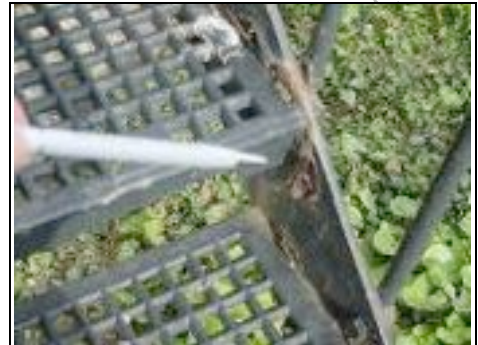
Please note we have not carried out a survey for fire or anything resembling this. We would however comment that fire regulations, of course is an important matter. We noted the rear metal fire escape is rusting.

Rusting to fire escape

ACTION REQUIRED: Apply rust stop agent, repair as necessary and redecorate.

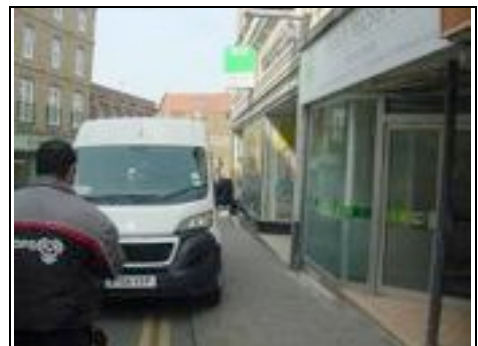
During the course of the survey the high street did get congested so deliveries may be a problem.

Congestion in road

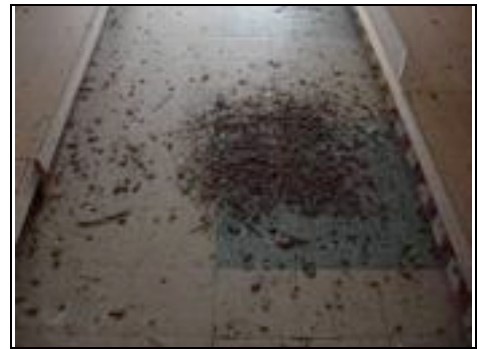
We noted within the suspended tile system at first floor level signs that Pigeons have been nesting between the structural floor level and the suspended ceiling level.

Pigeon mess

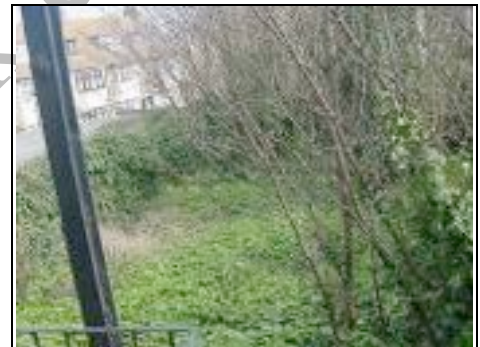
When we spoke to a neighbouring property we were advised that as the land to the rear was above general land in the area it discharges onto their property. You may or may not be legally liable for this but we would suggest as an act of neighbourliness that you do consult the residential neighbours on the left hand side.

Land to rear

The boundary garden is overgrown and the boundary fence on the right hand side is defective and part of the boundary wall has been knocked over.

ACTION REQUIRED: We would start by negotiating with the neighbours and adding weepholes and possibly adding a French drain/land drain to give a definite direction to the rainwater/groundwater.
